**Flood Control Project Maintenance
Levee Inspections**

Fall 2016 Levee Maintenance Deficiency Summary Report

San Joaquin River Basin

Reclamation District No. 0404 Boggs

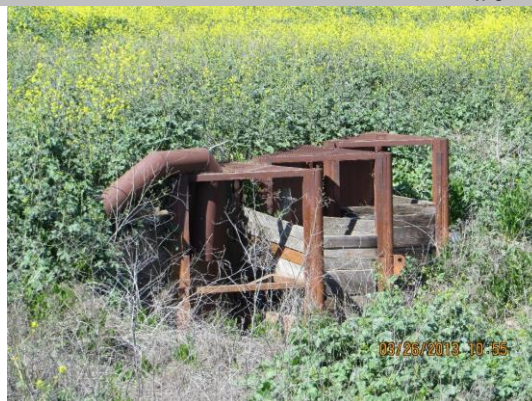
Photo 1 of 2 : UCIP_FA_2016_11087_20041.jpg

LM Start	0.65	Rating **	M	Issue No.	108 (cont)
LM End	0.65	Issue Type +	En	Location *	WS

LS- intake structure

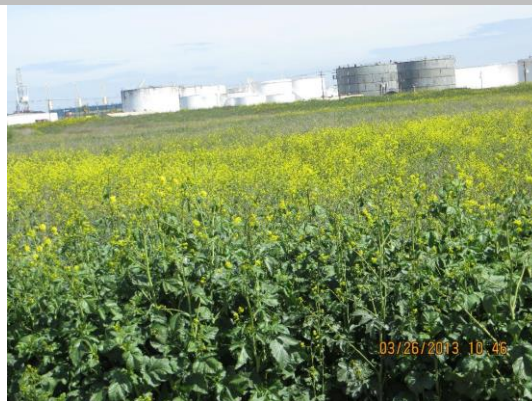
Photo 2 of 2 : UCIP_FA_2016_11087_20040.jpg

LS- overview of land side of the levee.

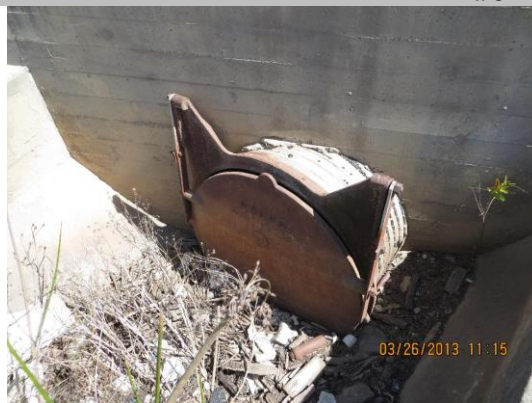
Photo 1 of 2 : UCIP_FA_2016_46628_19962.jpg

LM Start	0.75	Rating **	U	Issue No.	113
LM End	0.75	Issue Type +	En	Location *	LS
Category	Supplemental			GPS Latitude/Longitude	
				Start	End
Item	DWR UCIP Field Study			37.937657 °	37.937657 °
				-121.334158 °	-121.334158 °
DWR ID					
Comment Code					
Inspector Comment					
FS_ID:46628					
DS_ID:17945					
EP_NO: N/A					
Repair Type: Urgent					
Crossing Status: Found					
UCIP Comments: Partially burried flap gate					
FIELD_STRUCT_DESC: 42-inch CM drainage pipe 18.0 FBC. Flap gate, concrete headwall and spillway on WS. Pumphouse on LS.					
Abandoned concrete headwall, power pole, and 2 wooden piles found on LS. O&M #: SJR 001					
FS Date: 8/4/2015

WS- drainage outlet structure and CM pipe with flapgate

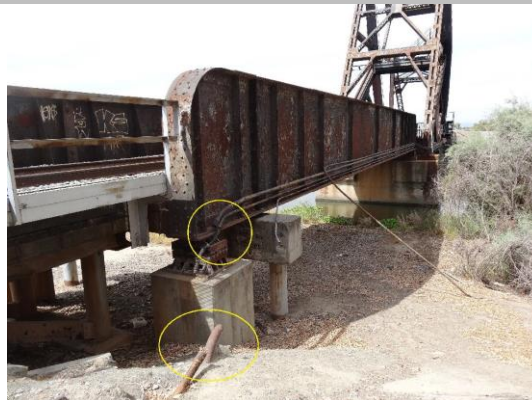
Photo 2 of 2 : UCIP_FA_2016_46810_74754.jpg

FS_ID:46810
DS_ID:17946
EP_NO: N/A
Repair Type: Non-Urgent
Crossing Status: Found
UCIP Comments: Appears abandoned; if so should be done so properly.
FIELD_STRUCT_DESC: Underground telephone cable through levee and across channel. Non-operational.
FS Date: 8/4/2015

WS view looking west: conduits thru levee and attached to bridge

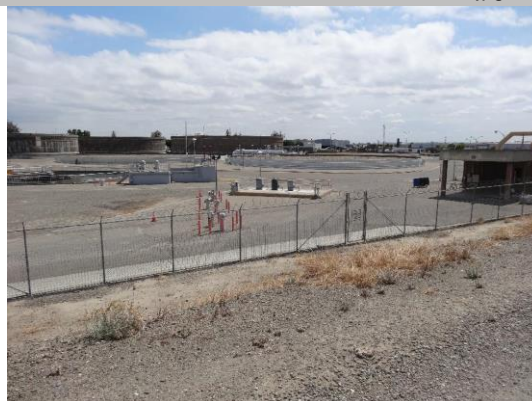
Photo 1 of 2 : UCIP_FA_2016_46801_74745.jpg

Comment Code					
Inspector Comment					
FS_ID:46801					
DS_ID:25128					
EP_NO: 1164					
Repair Type: Non-Urgent					
Crossing Status: Indicator Found					
UCIP Comments: Conversation with WWTP engineer Ali Gharegozloo suggested this pipe has been welded shut. If so, mode of abandonment needs verification.					
FIELD_STRUCT_DESC: 60-inch reinforced concrete sewage pipe 27					
FBC. Reinforced concrete apron and cut-off walls, steel sheet piling apron installed with pipe on WS slope. Headwall, stairs, pump with shutoff valve visible on WS slope. Apparent shut off valves 30 ft off LS toe in alignment with pipe. Permit No. 1164, 1947.					
FS Date: 7/9/2015

LS view: apparent shut off valves on WWTP property in alignment with 60-inch pipe.

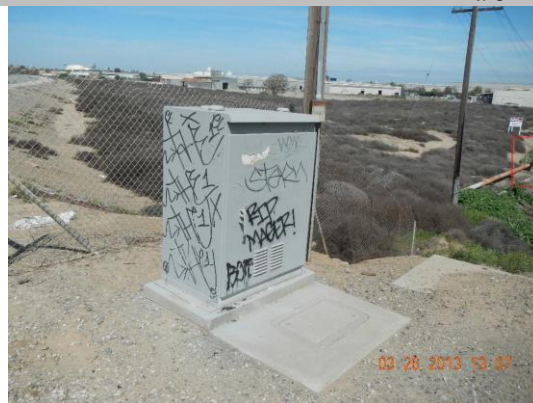
Photo 1 of 2 : UCIP_FA_2016_50763_20104.jpg

LM Start	1.55	Rating **	M	Issue No.	116
LM End	1.55	Issue Type +	En	Location *	CR
Category	Supplemental			GPS Latitude/Longitude	
				Start	End
Item	DWR UCIP Field Study			37.929046 °	37.929046 °
				-121.327248 °	-121.327248 °
DWR ID					
Comment Code					
Inspector Comment					
FS_ID:50763 DS_ID:18708 EP_NO: 4175 Repair Type: Non-Urgent Crossing Status: Found UCIP Comments: 11/17/2016 FPIIB Inspector Richard Willoughby noted 3-4 inch depression over pipes on crown, an indication of possible pipe collapse. (K. Fazel - UCIP) FIELD_STRUCT_DESC: 1 of 2. 12-inch-diameter steel pipes through levee, 5.0 feet below the crown. Siphon breakers on the waterward shoulder. Pump and electric control panel/pole on landside approximately 200 ft from levee. (Permit No. 4175-1963) FS Date: 11/17/2016

LS- overview of pipe and pump (far right)

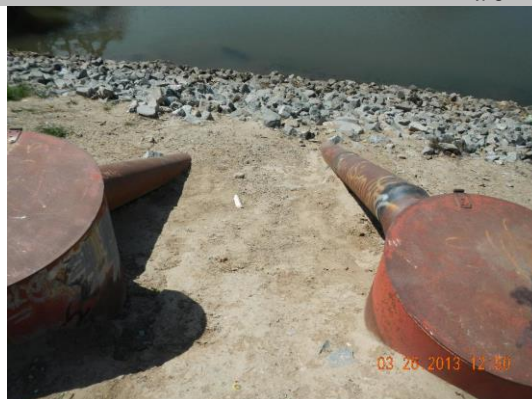
Photo 2 of 2 : UCIP_FA_2016_50763_20103.jpg

LM Start	1.55	Rating **	M	Issue No.	116 (cont)	
LM End	1.55	Issue Type +	En	Location *	CR	
Category	Supplemental			GPS Latitude/Longitude		
				Start		End
Item	DWR UCIP Field Study			37.929046 °		37.929046 °
				-121.327248 °		-121.327248 °
DWR ID						
Comment Code						
Inspector Comment						
FS_ID:50763 DS_ID:18708 EP_NO: 4175 Repair Type: Non-Urgent Crossing Status: Found UCIP Comments: 11/17/2016 FPIIB Inspector Richard Willoughby noted 3-4 inch depression over pipes on crown, an indication of possible pipe collapse. (K. Fazel - UCIP) FIELD_STRUCT_DESC: 1 of 2. 12-inch-diameter steel pipes through levee, 5.0 feet below the crown. Siphon breakers on the waterward shoulder. Pump and electric control panel/pole on landside approximately 200 ft from levee. (Permit No. 4175-1963) FS Date: 11/17/2016

WS- steel pipes and siphon breakers in steel pipe risers.

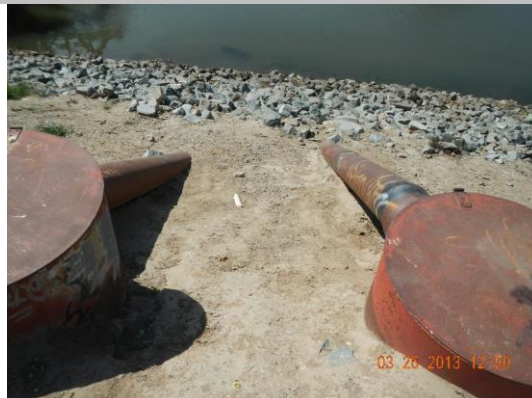
Photo 1 of 2 : UCIP_FA_2016_50764_19994.jpg

LM Start	1.55	Rating **	M	Issue No.	117
LM End	1.55	Issue Type +	En	Location *	CR
Category	Supplemental			GPS Latitude/Longitude	
				Start	End
Item	DWR UCIP Field Study			37.929046 °	37.929046 °
				-121.327248 °	-121.327248 °
DWR ID					
Comment Code					
Inspector Comment					
FS_ID:50764 DS_ID:17955 EP_NO: 4175 Repair Type: Non-Urgent Crossing Status: Found UCIP Comments: 11/17/2016 FPIIB Inspector Richard Willoughby noted 3-4 inch dip in crown over pipes, an indication of possible pipe collapse. (K. Fazel - UCIP) FIELD_STRUCT_DESC: 2 of 2. 12-inch-diameter pipes through levee, 5.0 feet below the crown. Siphon breakers on the waterward shoulder. Power pole, electric control panel and pump about 200 ft from the levee on landside. (Permit No. 4175-1963) FS Date: 11/17/2016

WS- steel pipes and siphon breakers in steel pipe risers.

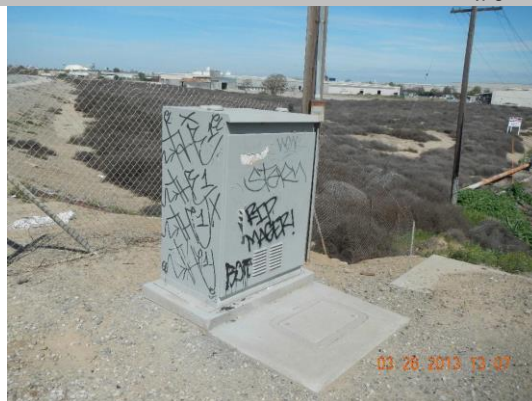
Photo 2 of 2 : UCIP_FA_2016_50764_19996.jpg

LM Start	1.55	Rating **	M	Issue No.	117 (cont)	
LM End	1.55	Issue Type +	En	Location *	CR	
Category	Supplemental			GPS Latitude/Longitude		
				Start		End
Item	DWR UCIP Field Study			37.929046 °	37.929046 °	
				-121.327248 °	-121.327248 °	
DWR ID						
Comment Code						
Inspector Comment						
FS_ID:50764 DS_ID:17955 EP_NO: 4175 Repair Type: Non-Urgent Crossing Status: Found UCIP Comments: 11/17/2016 FPIIB Inspector Richard Willoughby noted 3-4 inch dip in crown over pipes, an indication of possible pipe collapse. (K. Fazel - UCIP) FIELD_STRUCT_DESC: 2 of 2. 12-inch-diameter pipes through levee, 5.0 feet below the crown. Siphon breakers on the waterward shoulder. Power pole, electric control panel and pump about 200 ft from the levee on landside. (Permit No. 4175-1963) FS Date: 11/17/2016

LS- pipe and pump on far left.

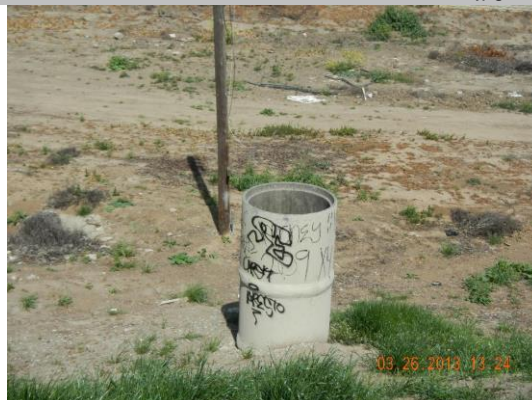
Photo 2 of 2 : UCIP_FA_2016_40487_20063.jpg

LM Start	1.64	Rating **	M	Issue No.	109
LM End	1.64	Issue Type +	En	Location *	WS
Category	Supplemental			GPS Latitude/Longitude	
				Start	End
Item	DWR UCIP Field Study			37.928090 °	37.928090 °
				-121.326215 °	-121.326215 °
DWR ID					
Comment Code					
Inspector Comment					
FS_ID:40487 DS_ID:18812 EP_NO: 10897 Repair Type: Non-Urgent Crossing Status: Found UCIP Comments: Abandoned crossing. WS pipe capped with steel pipe and LS pipe cut. FIELD_STRUCT_DESC: Abandoned 14-inch irrigation pipe. 3.0 feet below levee crown (Permit No. 10897). FS Date: 3/26/2013

LS- concrete standpipe on levee slope

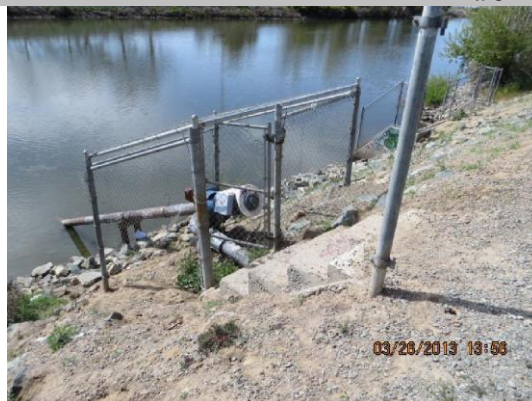
Photo 1 of 2 : UCIP_FA_2016_40797_20073.jpg

LM Start	1.81	Rating **	M	Issue No.	110
LM End	1.81	Issue Type +	En	Location *	LS
Category	Supplemental			GPS Latitude/Longitude	
				Start	End
Item	DWR UCIP Field Study			37.926168 °	37.926168 °
				-121.324514 °	-121.324514 °
DWR ID					
Comment Code					
Inspector Comment					
FS_ID:40797					
DS_ID:17961					
EP_NO: 6560					
Repair Type: Non-Urgent					
Crossing Status: Found					
UCIP Comments: Damaged siphon breaker in pipe riser near the landward shoulder.					
FIELD_STRUCT_DESC: 8-inch pipe through the levee, 7.0 feet below the crown, chain link fence around pump and motor on the waterward slope. (Permit. No. 6560)					
FS Date: 3/26/2013

WS- slanted pump, pipe, and concrete steps on levee slope.

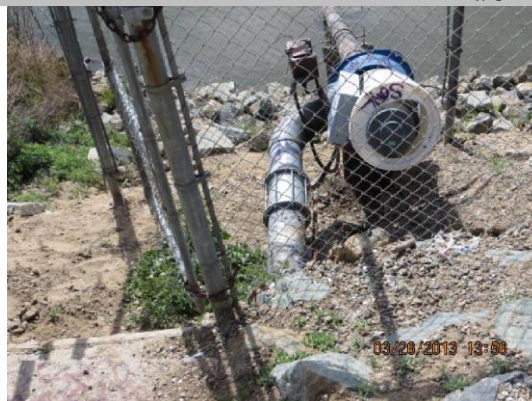
Photo 2 of 2 : UCIP_FA_2016_40797_20072.jpg

LM Start	1.81	Rating **	M	Issue No.	110 (cont)	
LM End	1.81	Issue Type +	En	Location *	LS	
Category	Supplemental			GPS Latitude/Longitude		
				Start	End	
Item	DWR UCIP Field Study			37.926168 °	37.926168 °	
				-121.324514 °	-121.324514 °	
DWR ID						
Comment Code						
Inspector Comment						
FS_ID:40797						
DS_ID:17961						
EP_NO: 6560						
Repair Type: Non-Urgent						
Crossing Status: Found						
UCIP Comments: Damaged siphon breaker in pipe riser near the landward shoulder.						
FIELD_STRUCT_DESC: 8-inch pipe through the levee, 7.0 feet below the crown, chain link fence around pump and motor on the waterward slope. (Permit. No. 6560)						
FS Date: 3/26/2013

WS- slanted pump, and pipe on levee slope.

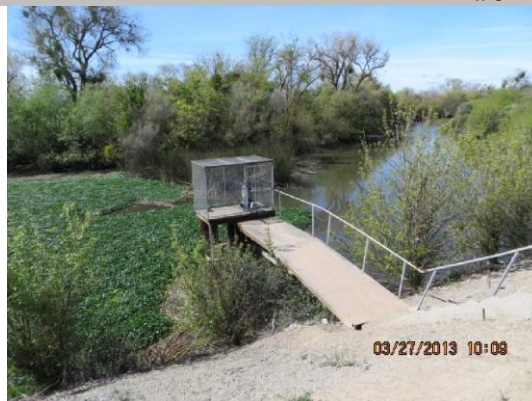
Photo 1 of 2 : UCIP_FA_2016_10908_18182.jpg

LM Start	0.73	Rating **	M	Issue No.	70
LM End	0.73	Issue Type +	En	Location *	LS
Category	Supplemental			GPS Latitude/Longitude	
				Start	End
Item	DWR UCIP Field Study			37.919336 °	37.919336 °
				-121.306782 °	-121.306782 °
DWR ID					
Comment Code					
Inspector Comment					
FS_ID:10908					
DS_ID:18781					
EP_NO: 3340A					
Repair Type: Non-Urgent					
Crossing Status: Found					
UCIP Comments: - Not working for 5 years- Golf club staff- Wooden					
Walkway; Concrete steps- Damaged siphon breaker					
FIELD_STRUCT_DESC: 6-inch pipe through the levee, 2.0 feet below					
the crown. Pump on pile structure in stream. Shut-off valve and siphon					
breaker on the waterward shoulder. Timber walkway on the waterward					
slope. One CM cutoff wall. (Permit No. 3340A)					
FS Date: 3/27/2013

WS- pump on steel structure and wooden walkway

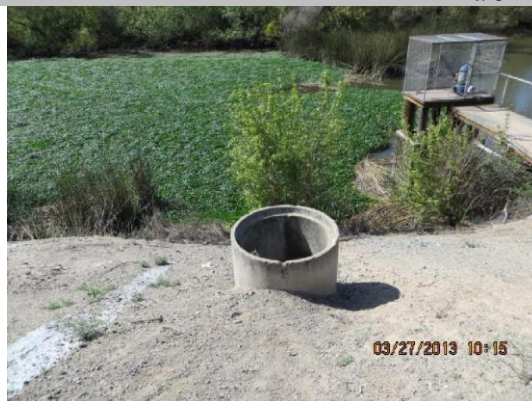
Photo 2 of 2 : UCIP_FA_2016_10945_18247.jpg

LM Start	0.74	Rating **	M	Issue No.	72 (cont)	
LM End	0.74	Issue Type +	En	Location *	LS	
Category	Supplemental			GPS Latitude/Longitude		
				Start	End	
Item	DWR UCIP Field Study			37.919308 °	37.919308 °	
				-121.306714 °	-121.306714 °	
DWR ID						
Comment Code						
Inspector Comment						
FS_ID:10945 DS_ID:18782 EP_NO: 4448 Repair Type: Non-Urgent Crossing Status: Found UCIP Comments: Concrete stairway on waterward slope- Not found. Pump was working during field survey. Siphon breaker cap missing. FIELD_STRUCT_DESC: 18-inch pipe through the levee, 9.3 feet below the crown, pump on the landward side. Siphon breaker in concrete well on the waterward shoulder. Two CM cutoff walls. (Permit No. 4448) FS Date: 3/27/2013

WS- concrete riser on steep levee slope

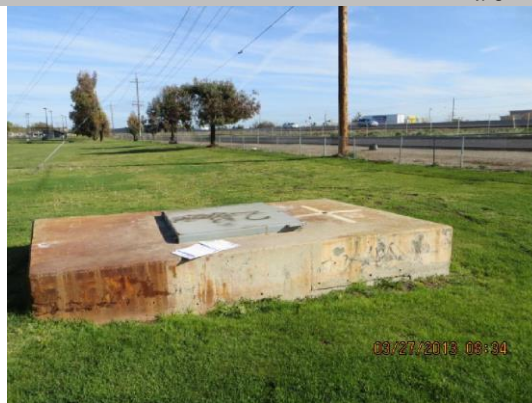
Photo 1 of 2 : UCIP_FA_2016_10846_18127.jpg

LM Start	1.76	Rating **	M	Issue No.	68
LM End	1.76	Issue Type +	En	Location *	WS
Category	Supplemental			GPS Latitude/Longitude	
				Start	End
Item	DWR UCIP Field Study			37.917284 °	37.917284 °
				-121.291740 °	-121.291740 °
DWR ID					
Comment Code					
Inspector Comment					
FS_ID:10846					
DS_ID:18804					
EP_NO: N/A					
Repair Type: Non-Urgent					
Crossing Status: Indicator Found					
UCIP Comments: Only a 7 ft x 14 ft concrete vault found on LS.Needs a sign post.Bob Winter from KSN(representative of RD 404) will investigate on this crossing.					
FIELD_STRUCT_DESC: 1 of 2. 42-inch-diameter pipelines under the levee. Pipes cross under the channel.					
FS Date: 3/27/2013

LS- 7' x 14' concrete vault.

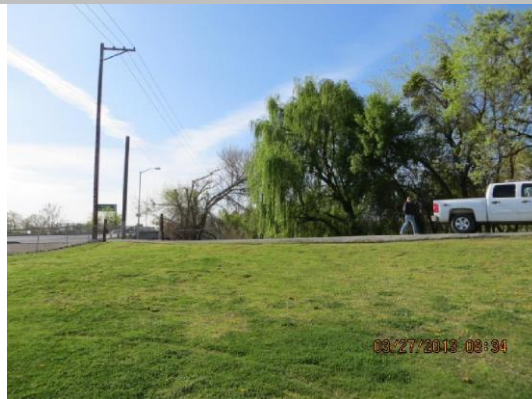
Photo 2 of 2 : UCIP_FA_2016_10846_18126.jpg

LM Start	1.76	Rating **	M	Issue No.	68 (cont)	
LM End	1.76	Issue Type +	En	Location *	WS	
Category	Supplemental			GPS Latitude/Longitude		
				Start	End	
Item	DWR UCIP Field Study			37.917284 °	37.917284 °	
				-121.291740 °	-121.291740 °	
DWR ID						
Comment Code						
Inspector Comment						
FS_ID:10846						
DS_ID:18804						
EP_NO: N/A						
Repair Type: Non-Urgent						
Crossing Status: Indicator Found						
UCIP Comments: Only a 7 ft x 14 ft concrete vault found on LS.Needs a sign post.Bob Winter from KSN(representative of RD 404) will investigate on this crossing.						
FIELD_STRUCT_DESC: 1 of 2. 42-inch-diameter pipelines under the levee. Pipes cross under the channel.						
FS Date: 3/27/2013

Crown view of the levee.

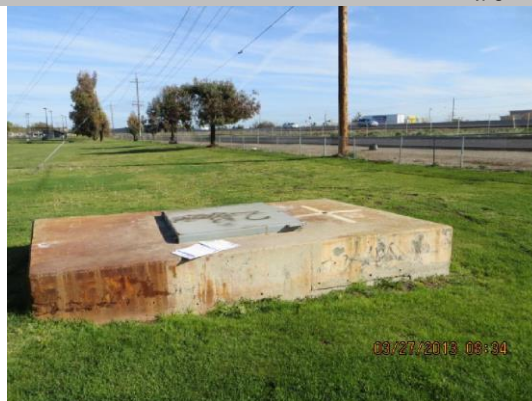
Photo 1 of 2 : UCIP_FA_2016_12426_20130.jpg

LM Start	1.76	Rating **	M	Issue No.	71
LM End	1.76	Issue Type +	En	Location *	WS
Category	Supplemental			GPS Latitude/Longitude	
				Start	End
Item	DWR UCIP Field Study			37.917284 °	37.917284 °
				-121.291740 °	-121.291740 °
DWR ID					
Comment Code					
Inspector Comment					
FS_ID:12426 DS_ID:18787 EP_NO: N/A Repair Type: Non-Urgent Crossing Status: Indicator Found UCIP Comments: Only a 7 ft x 14 ft concrete vault found on LS.Needs a sign post.Bob Winter from KSN(representative of RD 404) will investigate on this crossing. FIELD_STRUCT_DESC: 2 of 2. 42-inch-diameter pipelines under the levee. Pipes cross under the channel. FS Date: 3/27/2013

LS- 7' x 14' concrete vault.
